Tucannon River Restoration Effectiveness Monitoring: 2015 Results

Prepared for
Snake River Salmon Recovery Board
410B East Main Street
Dayton, Washington
99328

December 2016

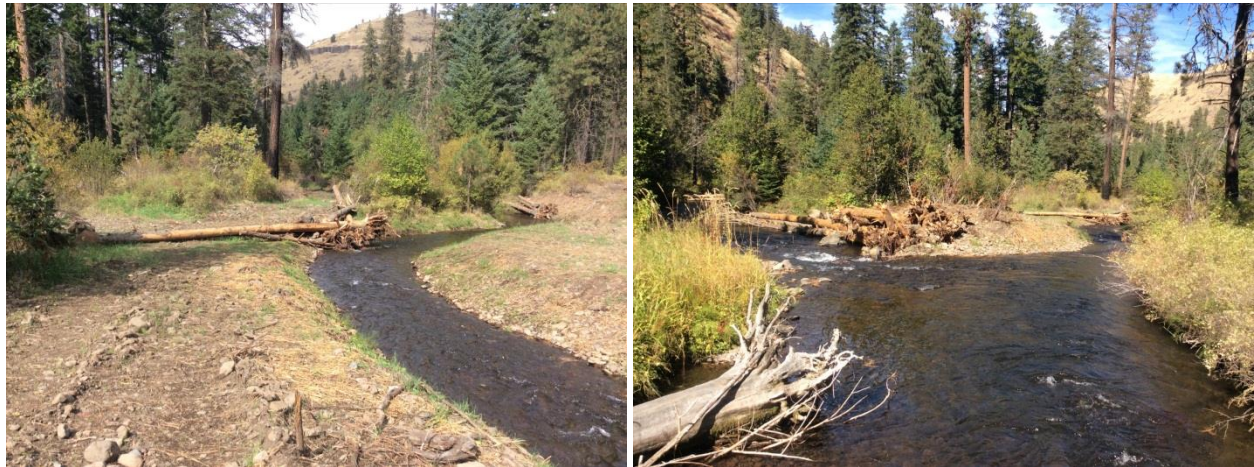
Figure 3. Restoration implemented in Project Area 1 included the creation of side channels and addition of LWD structures. No CHaMP site is present in this Project Area. Photos courtesy of the SRSRB.

Restoration in Project Area 1 (RM 49.5-50.1) downstream from Panjab Creek was sponsored by the Confederated Tribes of the Umatilla Indian Reservation and implemented in 2014. The objectives of this project were to increase channel complexity and side channel habitat. Approximately 231 key pieces of LWD were added and over 550 m of side channels were reconnected or created (Figure 3). More information about this project can be found at: [Project Area 1](#).

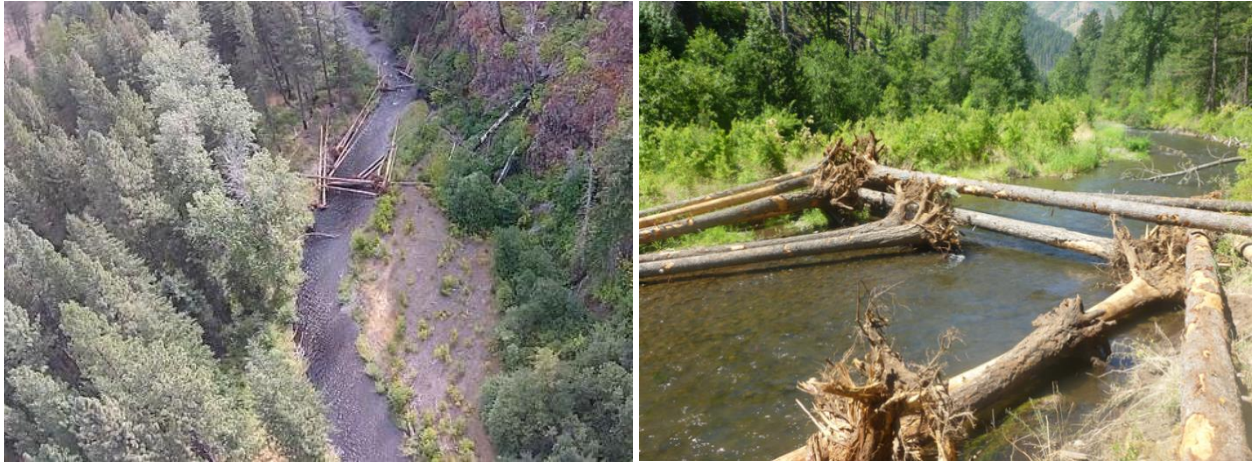
Figure 4. Restoration in Project Area 3 included the addition of LWD by helicopter. Photos show LWD structure located in CHaMP site 519039. Aerial photo courtesy of the Pomeroy Conservation District.

Restoration in Project Area 3 (RM 46.8-48.1) between Camp Wooten and the Little Tucannon River was implemented in 2014. The primary objective of this project was to increase channel complexity by adding LWD to the stream channel. Approximately 324 key pieces of LWD were added to the project area (Figure 4). This project was sponsored by the Confederated Tribes of the Umatilla Indian Reservation. More information about this project can be found at: [Project Area 3](#).

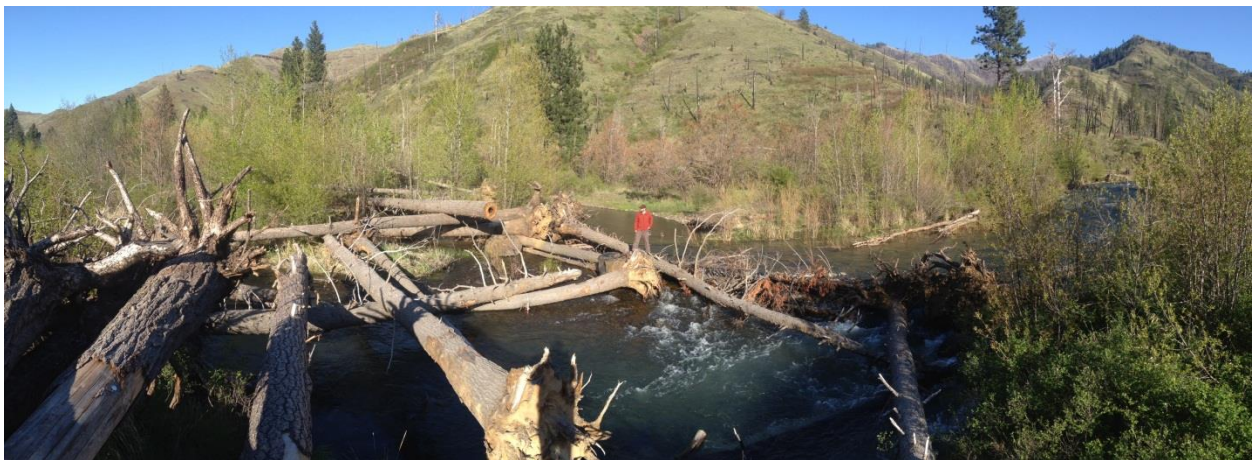
Figure 5. Restoration implemented in Project Area 10 included the addition of LWD.

Restoration in Project Area 10 (RM 42.4-44.0) between Beaver/Watson Lake and Big 4 Lake was sponsored by the WDFW and implemented in 2012. The objectives were to reduce channel confinement and incision as well as increase channel complexity. Over 350 key pieces of LWD were added during restoration (Figure 5). More information about this project can be found at: [Project Area 10](#).

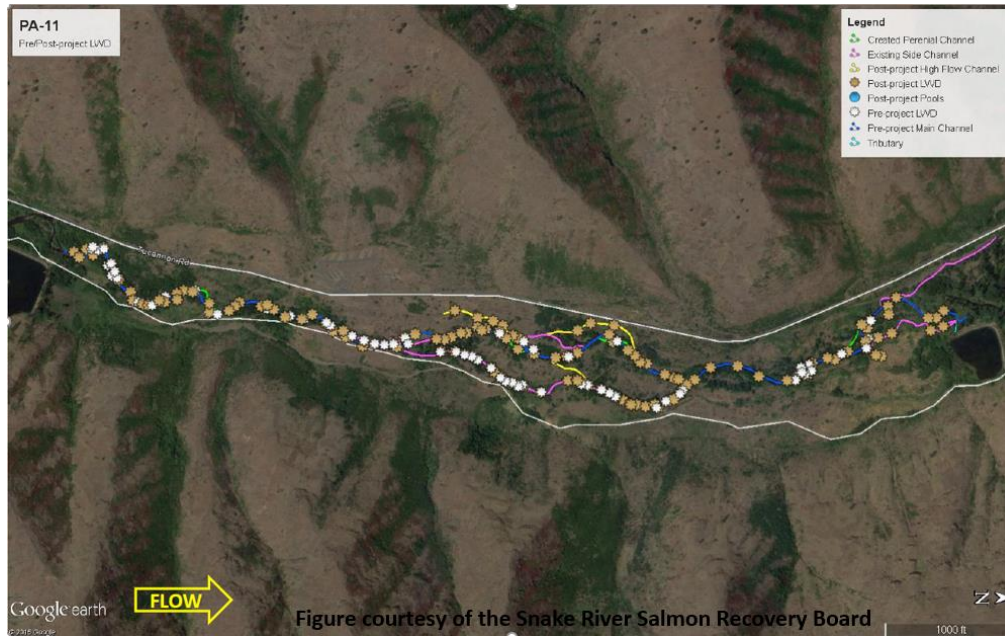
Figure 6. Project Area 11 pre and post-treatment conditions (from Rapid Habitat Surveys) for key LWD pieces and side channels. CHaMP post-treatment sample not available for this report.

Restoration in Project Area 11 (RM 40.5-41.8) between Deer and Watson Lakes was implemented in 2015. The objectives of this project were to improve and maintain floodplain connectivity and increase in-stream complexity. Within the Project Area, approximately 657 key LWD pieces were used to construct 94 LWD and ELJ structures (Figure 6). This project was sponsored by the Washington Department of Fish and Wildlife. More information on this project can be found at: [Project Area 11](#).

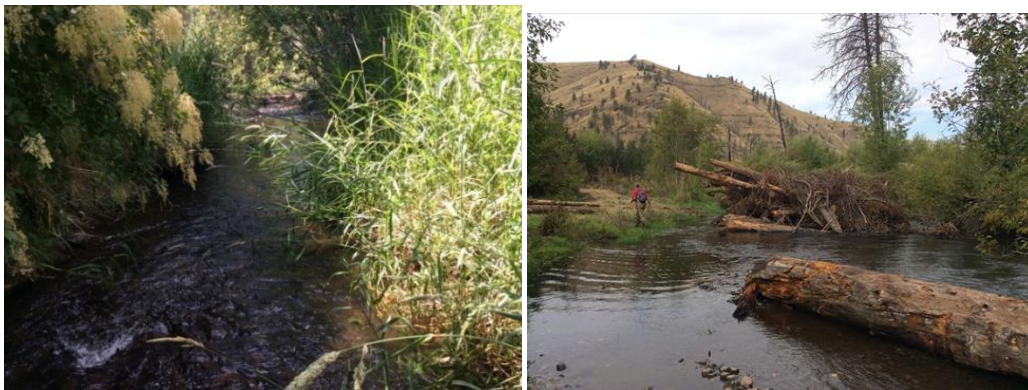
Figure 7. Restoration implemented in Project Area 14 included the creation and reconnection of side-channels (left photo) and installation of LWD structures (right photo). Photos courtesy of the SRSRB.

Restoration in Project Area 14 (RM 37.2-39.2) between Cummings Creek and the Tucannon Fish Hatchery was implemented in 2014 and included addition of over 700 key pieces of LWD and the creation/reconnection of over 2200 m of side channel (Figure 7). The objectives were to improve floodplain connectivity and instream channel complexity. This project was sponsored by the Washington Department of Fish and Wildlife. More information on this project can be found at: [Project Area 14](#).

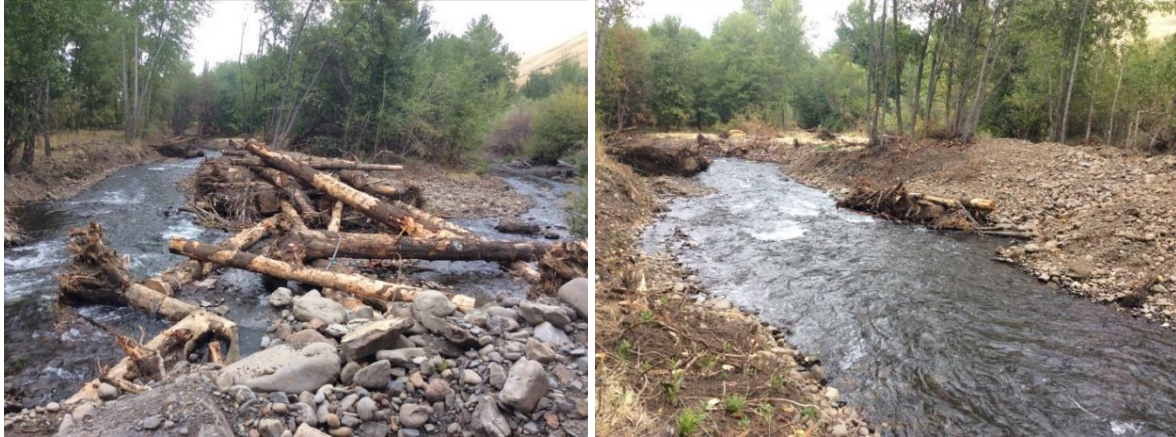
Figure 8. Restoration implemented in Project Area 15 included the installation of LWD structures (left photo) and the creation of new side channels (right photo). Photos courtesy of the SRSRB.

Restoration began in Project Area 15 (RM 36.4-37.2) downstream from the Wooten Wildlife Area headquarters in 2014 and was completed in 2015. The objectives include increasing channel complexity and side channels (Figure 8). Approximately 600 key pieces of LWD were added and 500 m of new side channels were created. More information on this project can be found at: [Project Area 15](#).

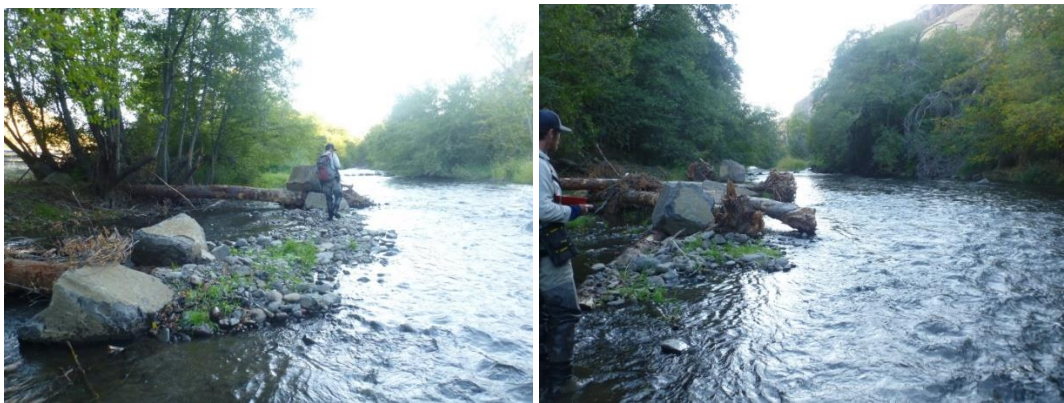
Figure 9. Photos showing two of eight LWD structures placed in Project Area 22. CHaMP post-treatment sample not available for this report.

Restoration in Project Area 22 (RM 29.3-30.3) upstream of Marengo was implemented in 2014. Eight LWD structures consisting of 36 key pieces of LWD were placed in order to increase channel complexity and pool habitat (Figure 9). This project was sponsored by the Columbia Conservation District. More information on this project can be found at: [Project Area 22](#).

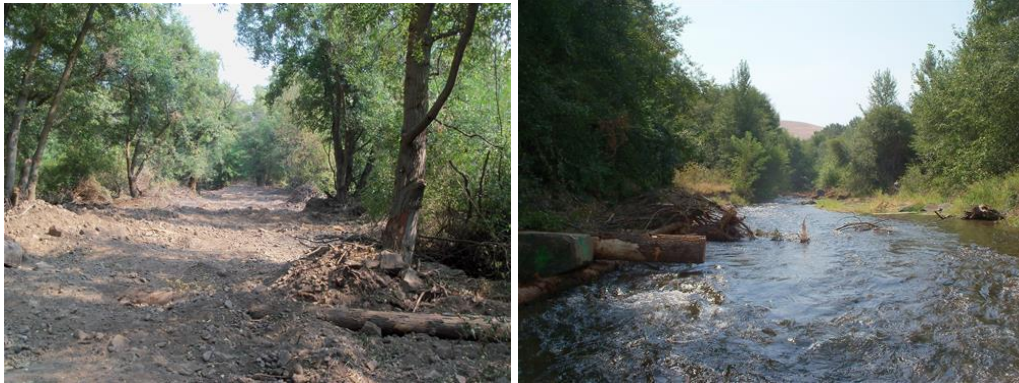
Figure 10. Restoration actions implemented in Project Area 23 included levee removal (left photo) and installation of LWD structures (right photo). Photos courtesy of the SRSRB. **CHaMP post-treatment sample not available for this report.**

Restoration in Project Area 23 (RM 28.3-29.3) upstream of Marengo was sponsored by the Columbia Conservation Districts and completed in 2015. The objectives were to increase floodplain connectivity and in-stream complexity. Almost 160 m of levee were removed and 12 LWD structures, consisting of 51 key pieces were constructed (Figure 10). More information can be found at: [Project Area 23](#).

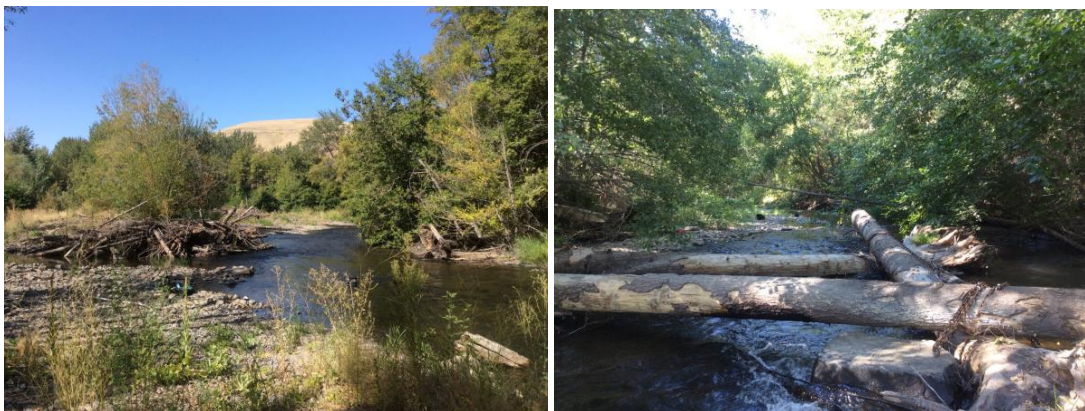
Figure 11. Photos showing two of 61 LWD structures constructed in Project Area 24. **CHaMP post-treatment sample not available for this report.**

Restoration in Project Area 24 (RM 27.5-28.25) upstream of Marengo was implemented in 2015. The objective was to increase floodplain connectivity, in-stream channel complexity, and side channel habitat. Almost 115 m of levee was removed and 61 LWD structures were built consisting of 498 key pieces (Figure 11). CCD was the sponsor and information can be found at: [Project Area 24](#).

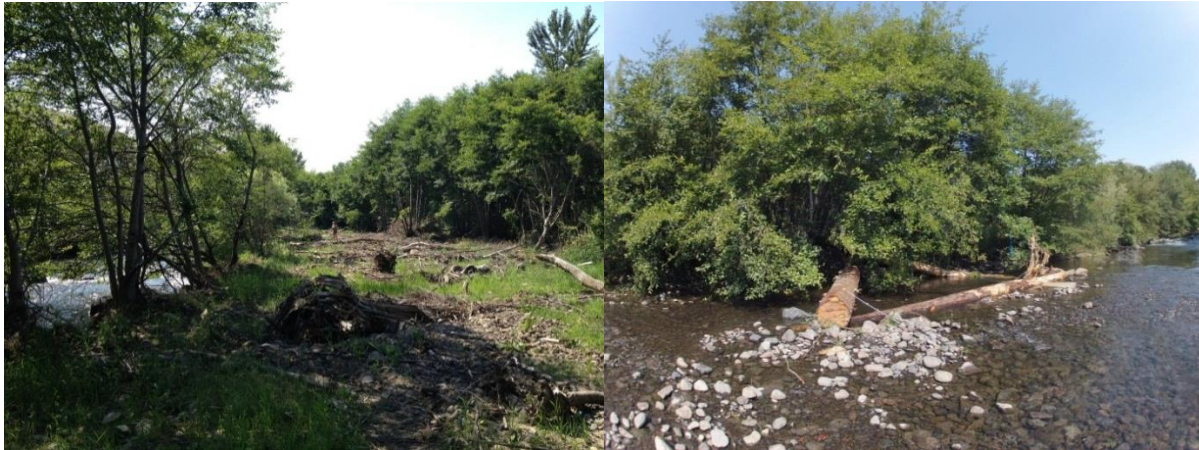
Figure 12. Restoration actions implemented in Project Area 26 included levee removal (left photo) in 2011 and LWD placement (right photo) in 2012. Photos courtesy of the SRSRB.

Restoration in Project Area 26 (RM 23.7-26.9) downstream of Marengo was first implemented in 2011. The objective was to reconnect the disconnected floodplain and riparian habitat by removing and setting back over 2500 and 3700 m of levee, respectively (Figure 12). In addition to the 2011 levee removal/setback, in 2013, 17 structures comprised of 78 key pieces of LWD were constructed. The objective of this additional restoration action was to provide habitat complexity and encourage channel migration. This project was sponsored by the Columbia Conservation District. More information on this project can be found at: [Project Area 26](#).

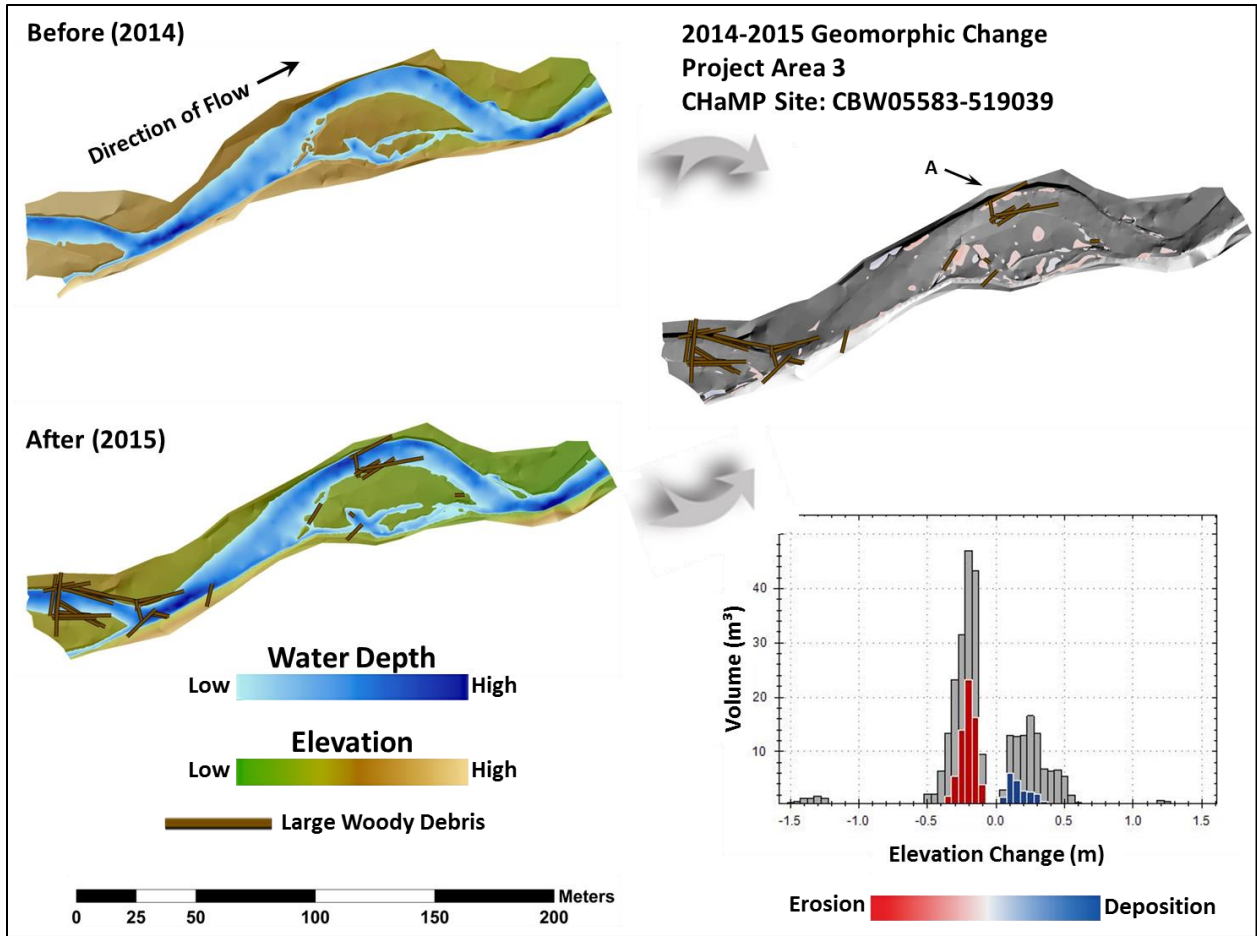
Figure 14. Geomorphic change detection for CHaMP site 519039 (Project Area 3) from 2014 (pre-treatment) to 2015 (post treatment). Approximate large wood piece locations derived from Google Earth.

Very little geomorphic change has been detected between pre (2014) and post treatment (2015) surveys in Project Area 3 (Figure 14). While there is little evidence that any major changes have occurred, there is evidence of scour near the banks where LWD was placed during restoration (Figure 14, label A). This lack of detectable change is primarily due to a lack of any high flow events during the winter and spring of 2015. Further geomorphic change is expected as high flows interact with the placed LWD to create scour near the LWD structures and deposition downstream.

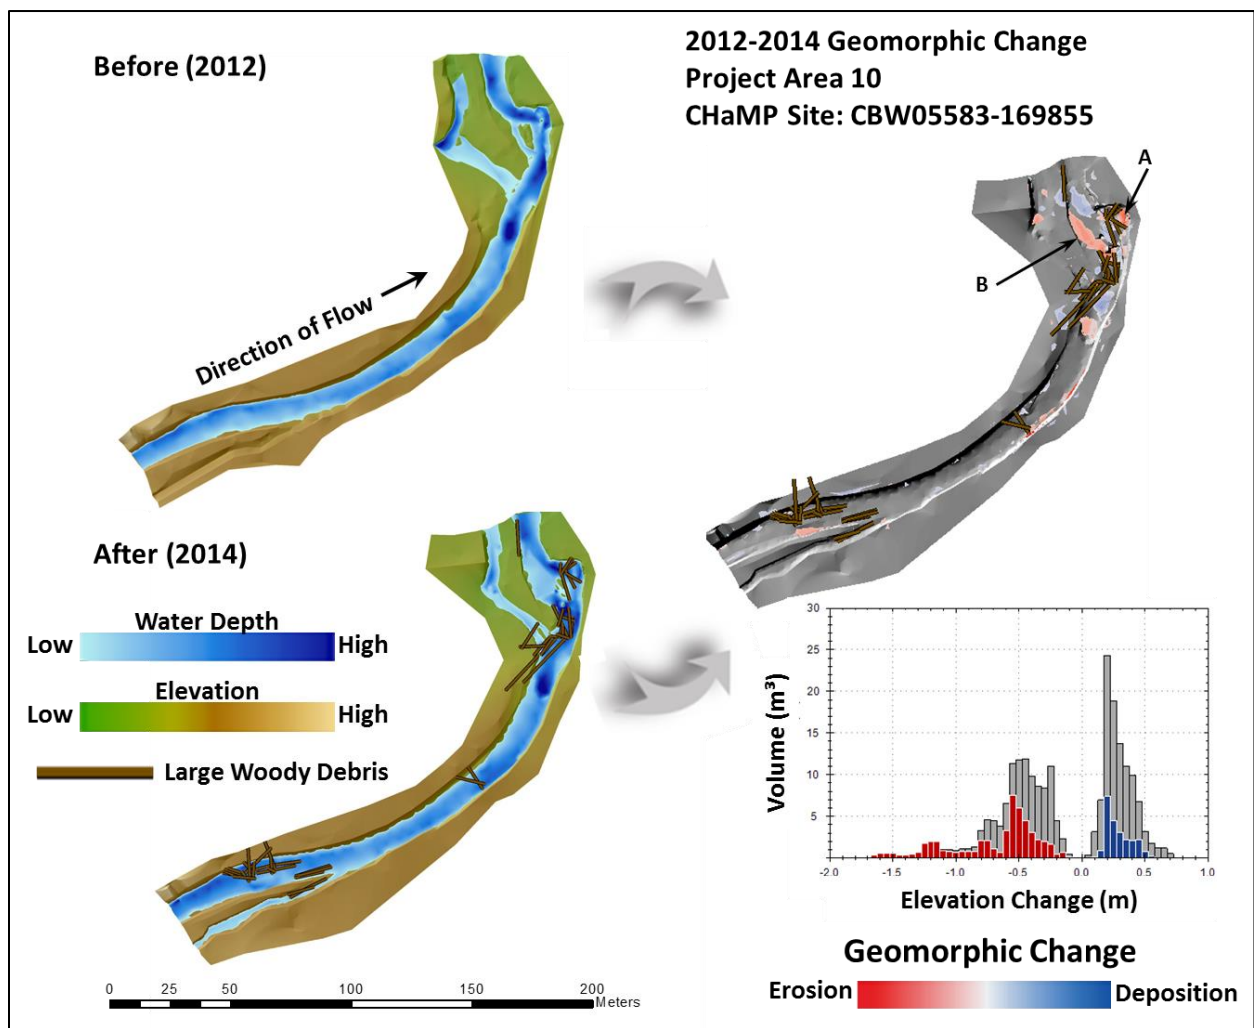
Figure 15. Geomorphic change detection for CHaMP site 169855 (Project Area 10) from 2012 to 2014. Approximate large wood piece locations derived from Google Earth.

Geomorphic change detection results between pre (2012) and two years post treatment (2014) surveys in Project Area 10 indicate geomorphic change in some areas of the stream channel (Figure 15). This includes erosion of the bank near where LWD was placed and where natural recruitment has occurred (Figure 15, label A). A small cutoff of an existing bar has also been created along with deposition at the downstream end of this cutoff (Figure 15, label B). Some of the deposition at this specific location is due to campers building rock dams. Overall, most of the geomorphic change has occurred in the downstream portion of the site where LWD was placed during restoration. Additional natural recruitment of LWD at this location has also been observed. Very little geomorphic change has been detected in the upper 2/3 of the site.

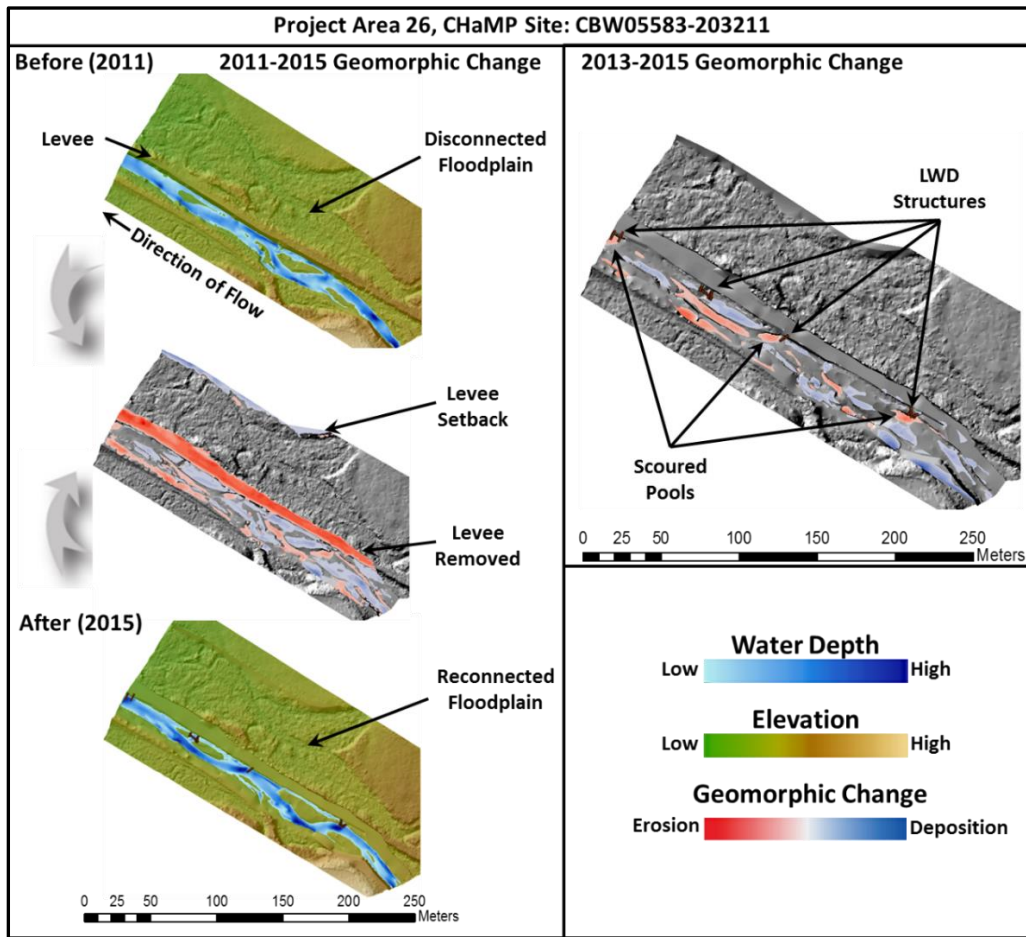
Figure 18. Geomorphic change detection for CHaMP site 203211 (Project Area 26) from 2011 to 2015 and from 2013 to 2015. A levee was removed at this site in 2011 and LWD structures were added in 2013.

The most evident change in Project Area 26 between 2011 (pre levee removal) and 2015 (post levee removal and LWD placement) is the removal of the levee and levee setback (Figure 18). Due to the levee removal, the river now has access to the floodplain. After installing LWD structures in 2013, a comparison of pre-treatment (2013) and post treatment (2015) surveys shows areas of pool forming erosion near LWD structures in association with downstream bar formation. Some of this scour near structures can be attributed to an increase in the percentage of pools at the site from 22% in 2013 to 33% in 2015.

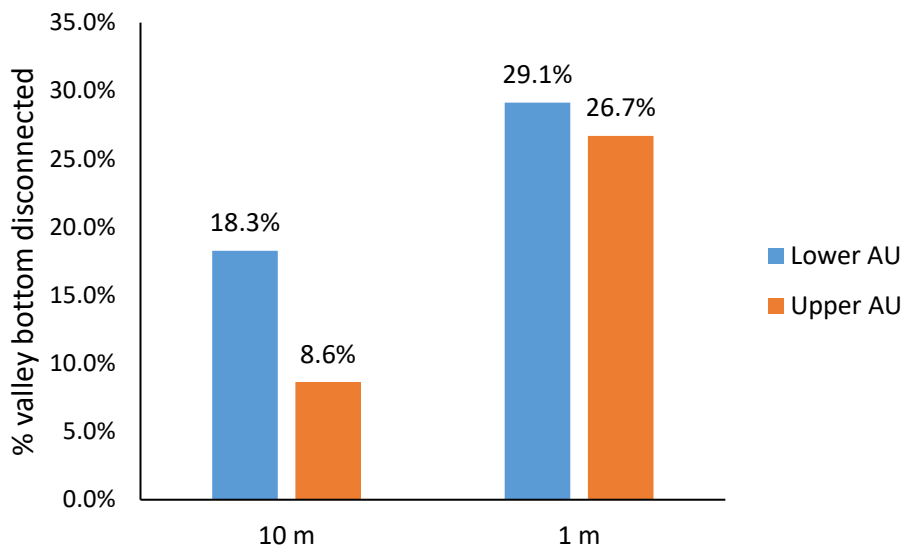
Figure 19. Proportion of historic valley bottom disconnected in the Lower and Upper Assessment units of the Tucannon River mainstem based on analysis using 10 m and 1 m digital elevation data.

As expected a significant amount of the historic floodplain is disconnected by infrastructure such as roads and levees. We compared confinement based on both 10 m and 1 m DEMs and found that using the 1 m DEM we were able to identify over twice as much disconnected valley bottom (27.9%) compared to using 10 m DEM (13.4%). There was more disconnected valley bottom in the Lower Assessment unit compared to the Upper Assessment unit regardless of DEM data used (Figure 19). Based on 1 m DEM, it appears that 345.4 acres in Lower Assessment unit and 1111.9 acres in Upper Assessment unit (total = 1457.3 acres) may be disconnected from historic floodplain habitat by existing infrastructure. These estimates were compiled from output from V-BET using 1 m DEM data, existing ADEQ GIS layers that identified levees, and additional visual inspection of the 1 m DEM and delineation of potential levees. A representative set of sites visits should be conducted to validate these estimates.

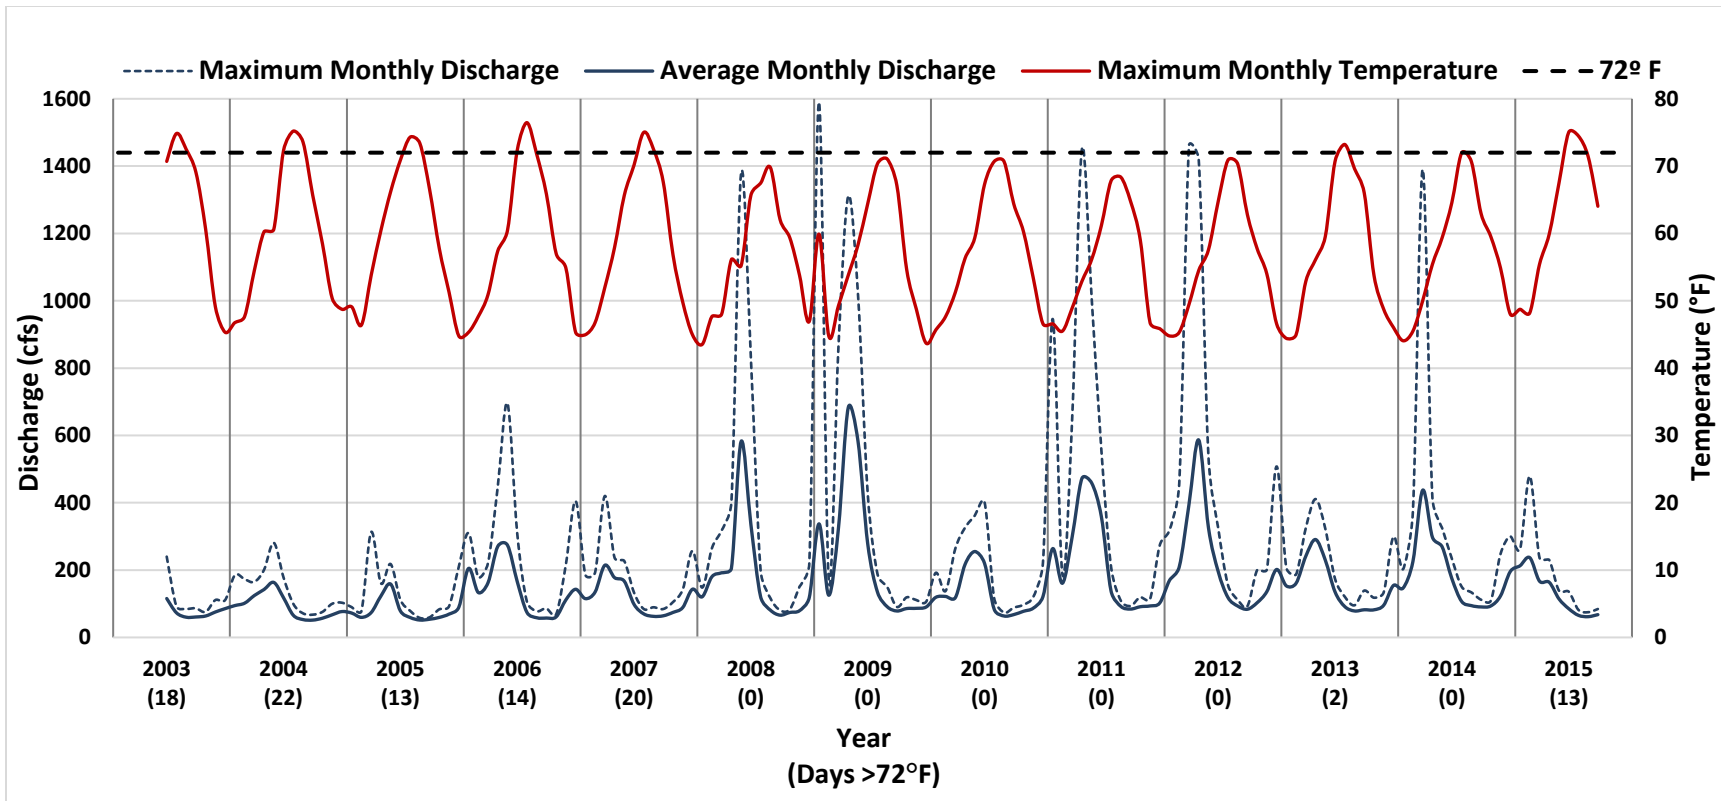
Figure 23. Monthly maximum (blue dashed line) and average discharge (solid blue line), maximum water temperature (red), and number of days water temperature exceeded 72° at Marengo from 2003-2015. Restoration target is < 4 days > 72° F. Note that temperature and flow records for 2003 only include data after the June 1 installation date and 2015 records only include data up to October 1 (end of Water Year).

The restoration target for water temperatures in both the lower and Upper Assessment unit is less than four days greater than 72° F (SRSRB 2011). Results derived from the Washington State Department of Ecology stream gauge at Marengo between 2003 and 2015 indicate a general decrease in the number of days exceeding 72° F until 2015, with no days exceeding 72° F from 2008-2012 (Figure 23). While temperature responses may be due to previous restoration actions aimed at improving upstream riparian conditions, the decrease in exceedance days also corresponds to a general increase in mean annual flows over the time period. Stream gauge information can be found at <https://fortress.wa.gov/ecy/eap/flows/station.asp?sta=35B150#block0>.
